Harper Memorial Library (D38), First Floor Classroom 130

VISUAL CHARACTER OF INTERIOR SPACES

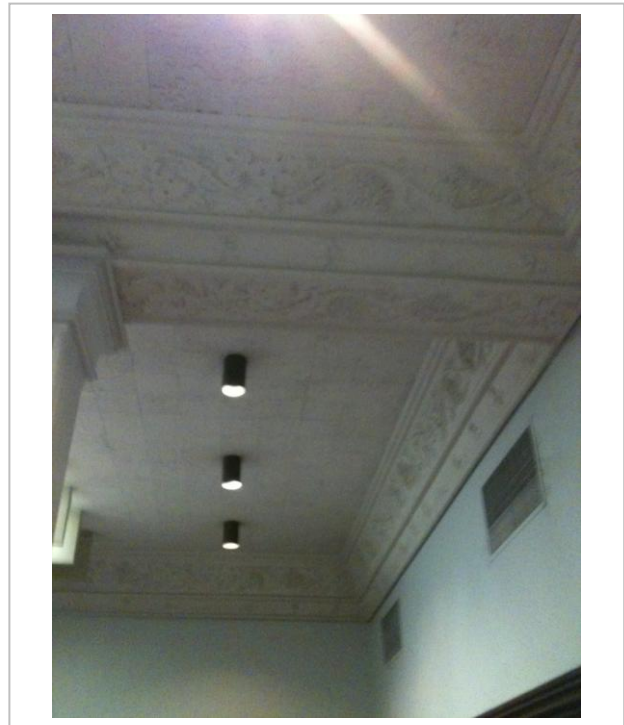
- Room Number: 130
- Floor Level: First
- Current Department: College Administration
- Net Assignable SF: 1977
- Current Primary Use: Classroom
- Current Adjacency: Classrooms
- Significant Prior Use:
- Significant Prior Department:
- Abuts an external wall: **Yes**
- Windows: **Light**
- Last Major Renovation:
- Period of Significance:
- HRS Rating Interior: 1 2 3 N.A
- Comment – Space report created for renovation in 2011

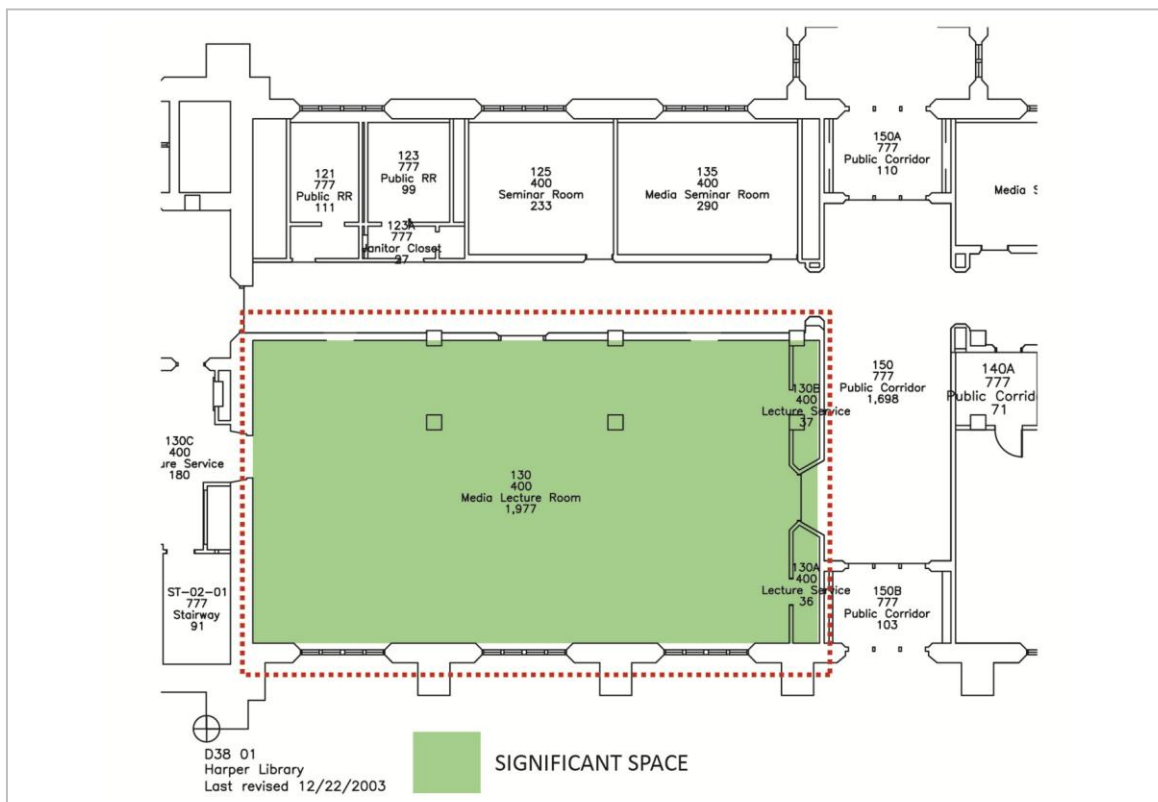
OVERALL CHARACTER

Dominating visual character: Highly ornamented plaster ceiling beams and cornice with residual wood paneled walls.

Walls (material, finish, trim): Wood paneling.

Windows (type, glazing): Original lead-camed casement units.

Ceilings (material, pattern, finish, trim): Painted ornamental plaster beams and cornice with applied acoustical tile.
