PLANING + DESIGN

Harper Memorial Library (D38), Third Floor Reading Room

VISUAL CHARACTER OF INTERIOR SPACES

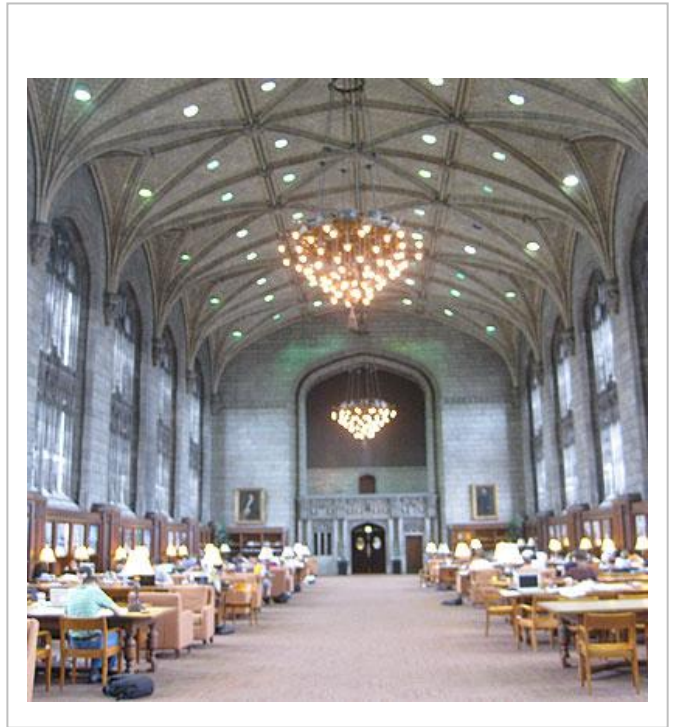
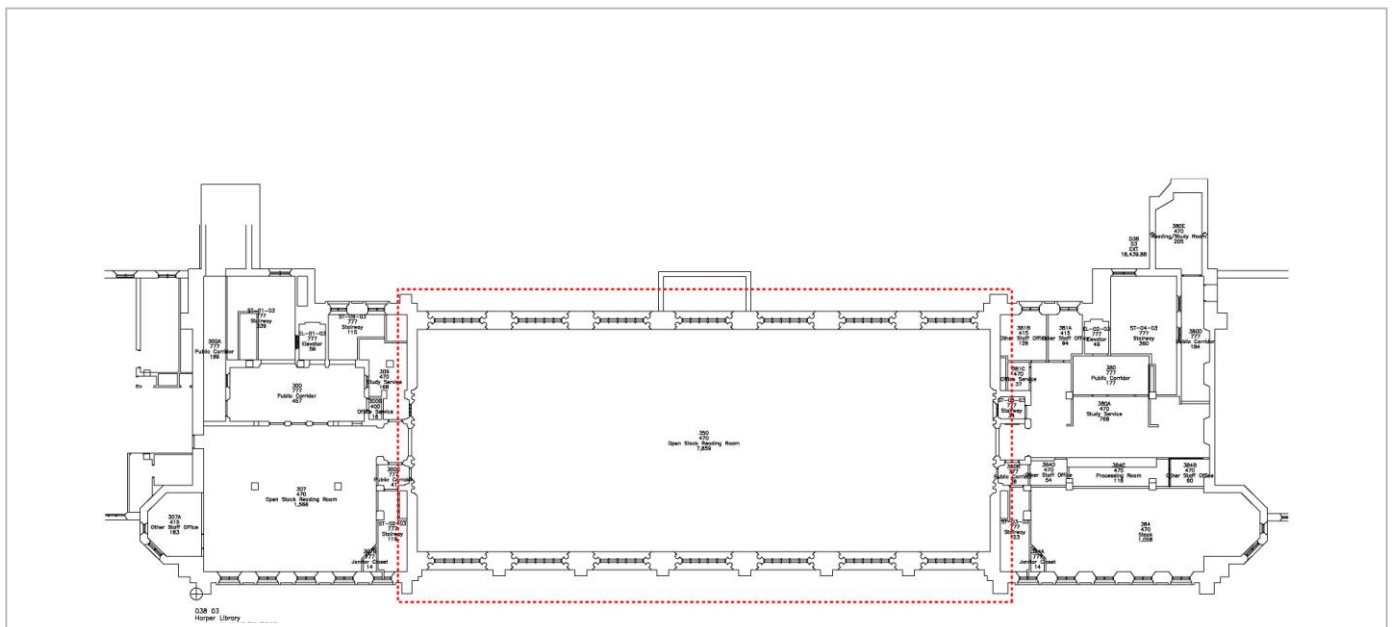
- Room Number: 350
- Floor Level: Third
- Current Department:
- Net Assignable SF:
- Current Department:
- Current Primary Use:
- Current Adjacency:
- Significant Prior Use:
- Significant Prior Department:
- Abuts an external wall: **Yes** No
- Windows: **Light** Views
- Last Major Renovation:
- Period of Significance:
- HRS Rating Interior: 1 2 3 N.A
- Comment -
